MISC. INFORMATION RELATED TO THE DISCUSSION of Idaho S1233

With recent crash test imagery where 100%-OEM cars and same cars fitted with non-OEM parts ( 2 identical cars repaired differently) are subjected to the identical crash test, we can now see visible, substantial structural failure in the non-OEM cars.

ATTACHMENT 2, FEBRUARY 1, 2024, JOHN MILLER

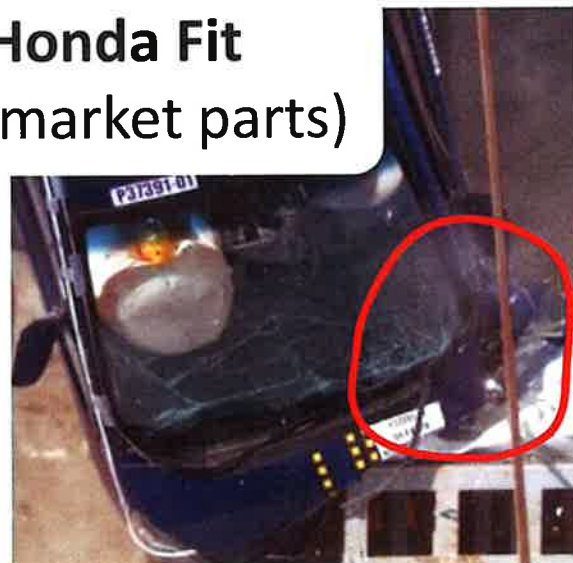
## 2013 Honda Fit (aftermarket parts)

The blue 2013 Fit received a variety of aftermarket parts, some certified, some not.

These included **Certified Automotive Parts Association** approved fenders and a **CAPA** certified hood, a non-**CAPA** aftermarket radiator support, an **NSF** certified bumper reinforcement bar, left and right hood hinges, wheel and windshield. All were installed using OEM repair procedures. Note that the OEM installation procedures do not change the fact of the quality of the **CAPA** certified or **NSF** certified parts.

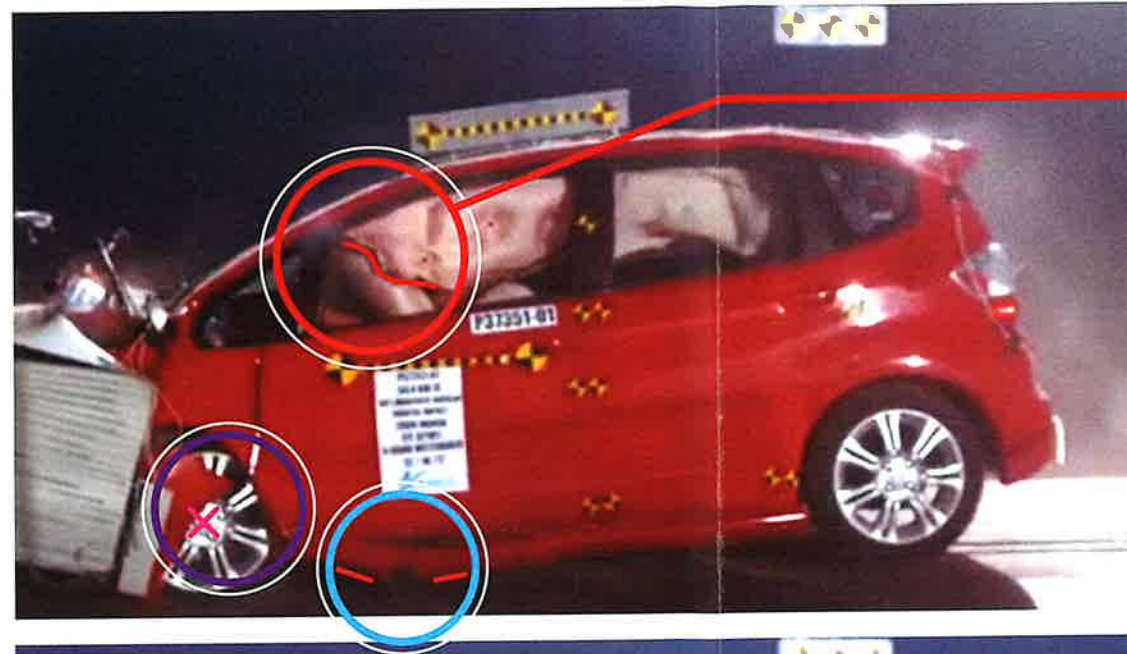
## 2009 Honda Fit (non-OEM parts)

Received unapproved repairs, including an adhesive-bonded roof (instead of welding it as Honda demands) and an aftermarket windshield. This emulated the conditions of the real-world crash which predecated these tests.

Note the junction of the curtain airbag where it intersects with the steering wheel bag. See how clearly different it looks than the unaltered control car. The steering wheel bag of the black car is clearly in a more advanced stage of deployment than the other 2 cars.

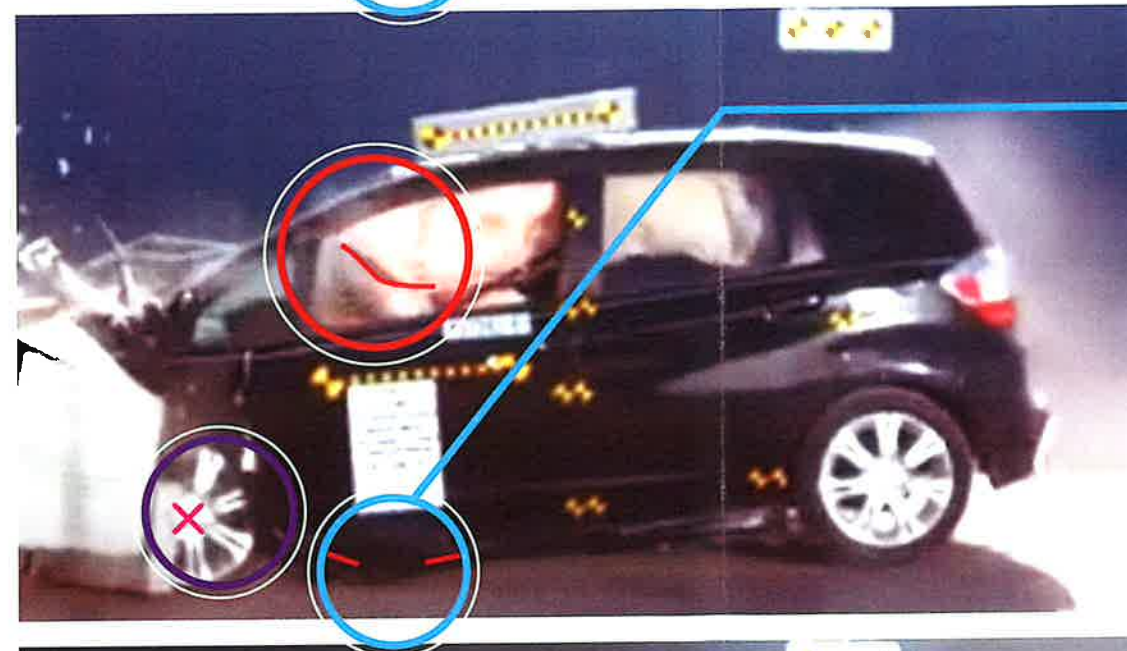
## 2010 Honda Fit (control)

An unaltered black 2010 Honda Fit was crashed as a control vehicle. the differences between the two experimental Fits and the control Fit are noticeable.

The buckle in the lower rocker panel is good. It demonstrates the absorption of the energy from the impact. The blue car's rocker panel is not absorbing the energy of the impact and front is collapsed further back than the two cars above.

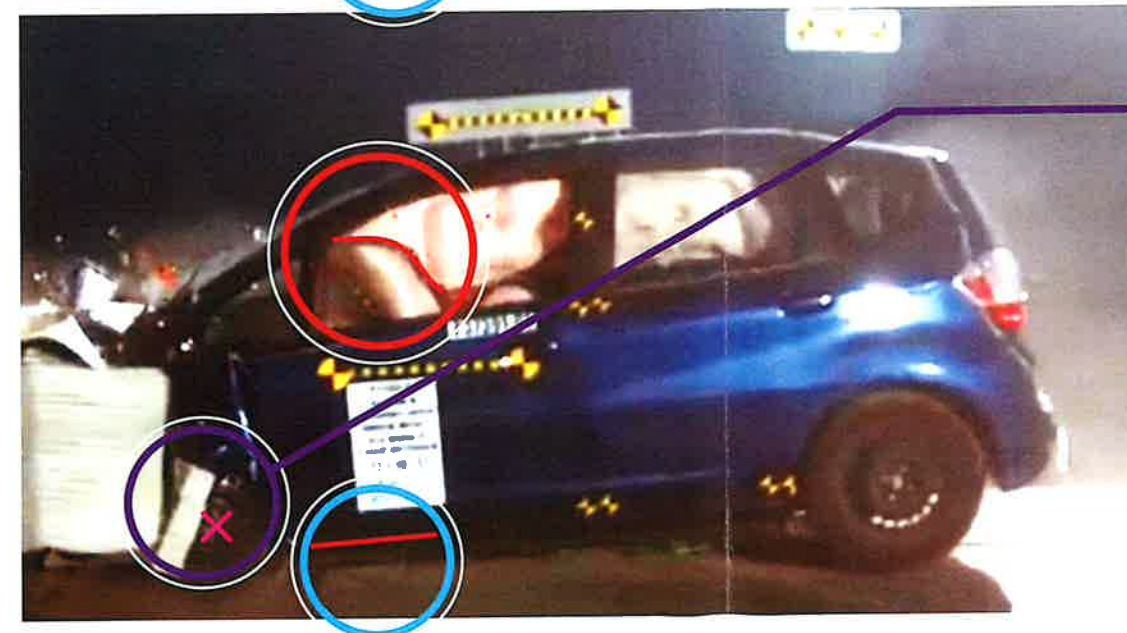
## 2013 Honda Fit (aftermarket parts)

A variety of aftermarket parts, both certified and not. **CAPA**-approved fenders and a **CAPA**-certified hood, a non-**CAPA** aftermarket radiator support, an **NSF**-certified bumper reinforcement bar, hood hinges, wheel and windshield.

The axle is clearly further back than the other examples. The floorboard in this car has been torn apart and separated.

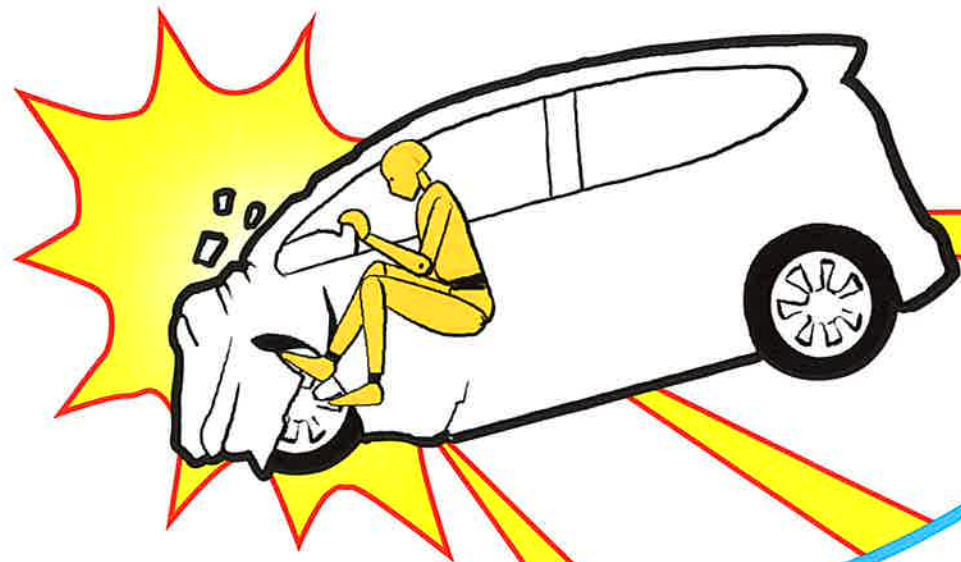
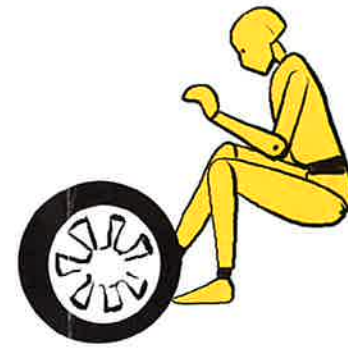
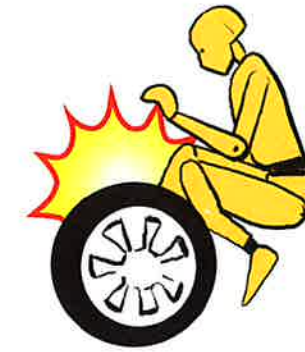
**AXLE DISPLACEMENT**

The wheel and axle structural strength is vital to the livelihood of the driver.

All parts in a repaired vehicle MUST work in unison for the safety of the driver, but often do not.

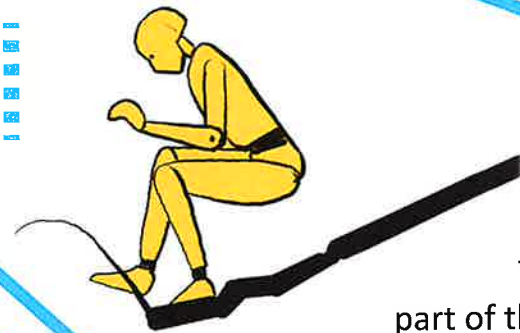
**ROCKER PANEL**

The rocker panel is a part of the lower unibody framework in this car model.

When there is no buckling in the lower rocker panel it is not absorbing the energy of the impact, endangering the driver.
